## MSP430F13x/14x/14x1 Device Erratasheet

### 1 Current Version

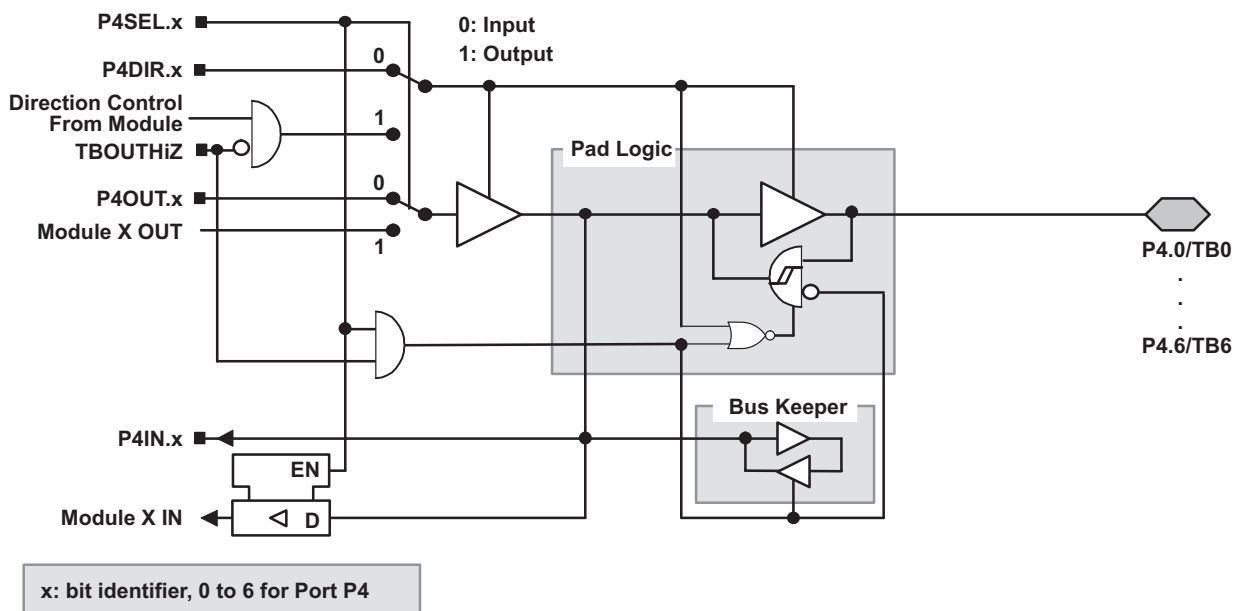
**Port Function as Specified**

**Description** Incorrect 3-state function of Ports P4.0/TB0 through P4.6/TB6 (TBoutHiZ control). If TBoutHiZ is set to high, all ports P4.0/TB0 through P4.6/TB6 are set to 3-state, independent of the P4SEL.x control signals. This means a port P4.x is switched to 3-state with TBoutHiZ, even if it is not selected for Timer\_B function. In addition, the ports P4.0/TB0 through P4.6/TB6 are switched to 3-state with TBoutHiZ, even if the port direction (direction control from module) is set to input. This is in accordance with the specification description but, nevertheless, is an unexpected behavior.

**Workaround** None

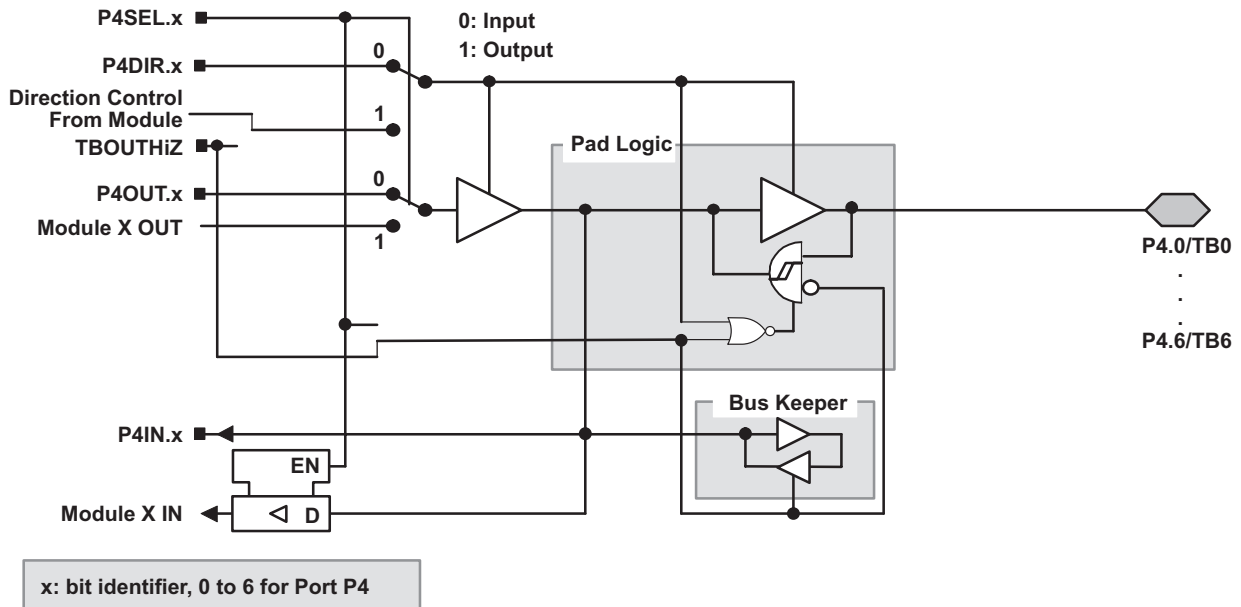
**Port Realization With TB3 Bug**

**TB3** *Timer\_B Module*

**Function** Port is switched to 3-state independent of selected function
