PIC24FJ256GA110 Family Silicon Errata and Data Sheet Clarification

The PIC24FJ256GA110 family devices that you have received conform functionally to the current Device Data Sheet (DS39905D), except for the anomalies described in this document.

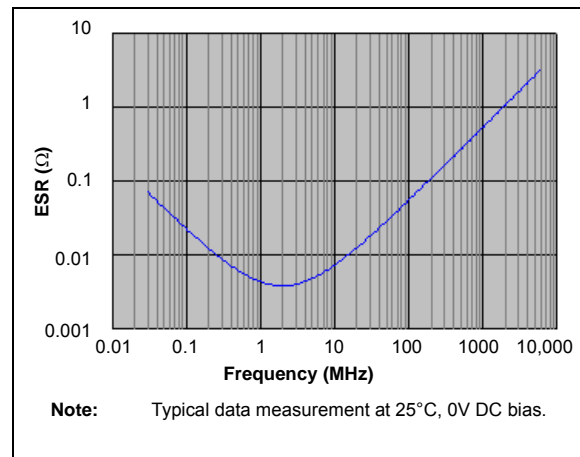
FIGURE 2-3 FREQUENCY vs. ESR PERFORMANCE FOR SUGGESTED VCAP

Designers may use [Figure 2-3](#) to evaluate ESR equivalence of candidate devices.

The placement of this capacitor should be close to VCAP/VDDCORE. It is recommended that the trace length not exceed 0.25 inch (6 mm). Refer to **Section 28.0 “Electrical Characteristics”** for additional information.

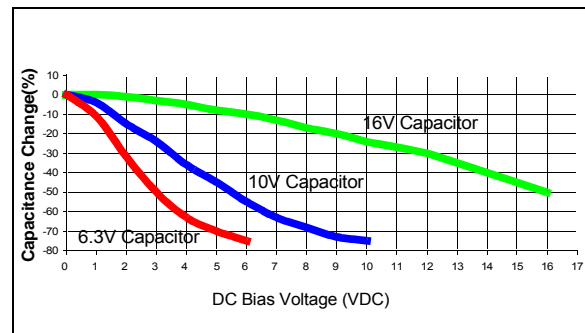
FIGURE 2-4 DC BIAS VOLTAGE vs. CAPACITANCE CHARACTERISTICS

A typical DC bias voltage vs. capacitance graph for 16V, 10V and 6.3V rated capacitors is shown in Figure 2-4.

When selecting a ceramic capacitor to be used with the internal voltage regulator, it is suggested to select a high-voltage rating, so that the operating voltage is a small percentage of the maximum rated capacitor voltage. For example, choose a ceramic capacitor rated at 16V for the 2.5V core voltage. Suggested capacitors are shown in Table 2-1.

The X5R and X7R capacitors typically exhibit satisfactory temperature stability (ex: $\pm 15\%$ over a wide temperature range, but consult the manufacturer's data sheets for exact specifications). However, Y5V capacitors typically have extreme temperature tolerance specifications of $+22\%/ -82\%$. Due to the extreme temperature tolerance, a 10 μF nominal rated Y5V type capacitor may not deliver enough total capacitance to meet minimum internal voltage regulator stability and transient response requirements. Therefore, Y5V capacitors are not recommended for use with the internal regulator if the application must operate over a wide temperature range.
